## Background

This company is a leading manufacturer of motorcycles. They demand the very best from themselves and from their vendors.

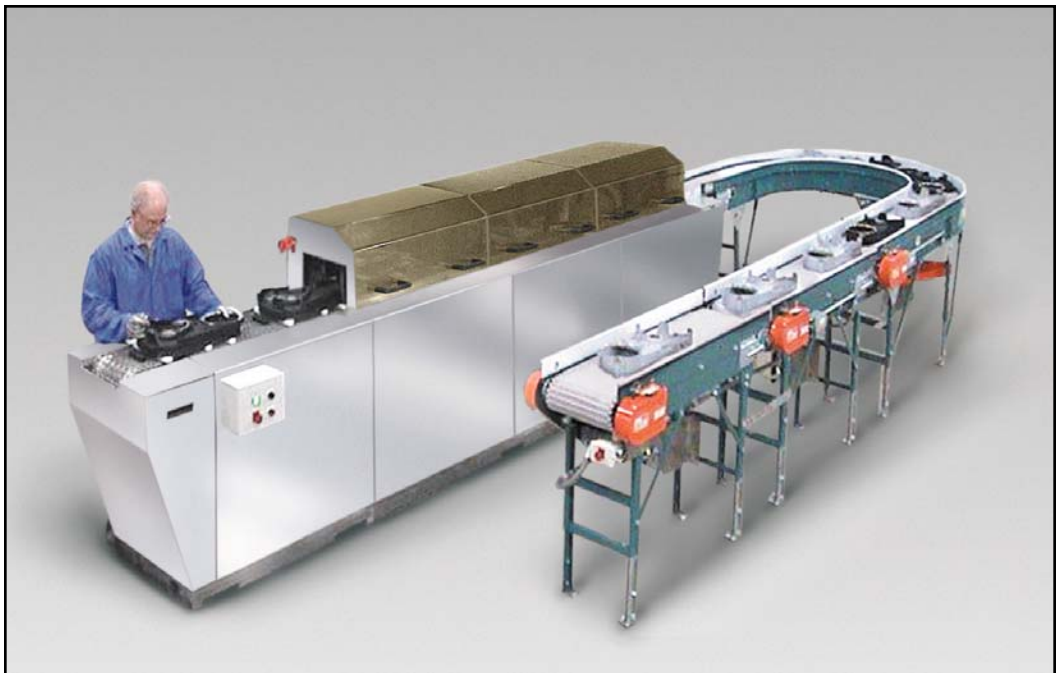
A C-14-S2/CD/DH conveyor washer with wash and dry modules and special air nozzles that blow-out difficult blind holes. The 14" conveyor belt going through the washer has plastic fixture bars. The return belts are all plastic.

They needed a machine to clean engine covers prior to "leak test" ... the system had to wash and dry the parts 100% and the parts had to be conveyed to the leak check unit. Also, the conveyor had to have multiple sections so that parts could move forward even if a part reached the very end of the system.
